How Can We Ensure Accessibility of Cultural Heritage? Toward Better Utilization of Existing Assets in Japanese Context

Satoshi Kose

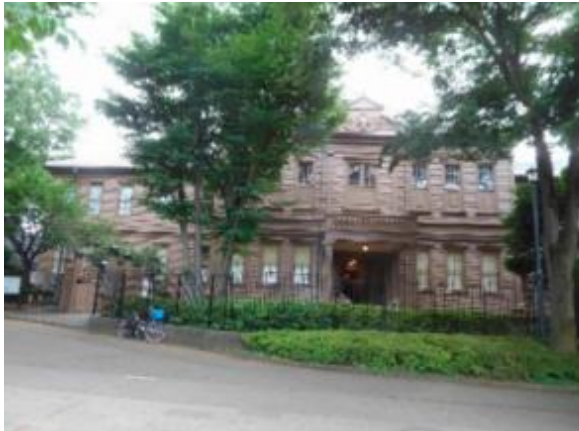
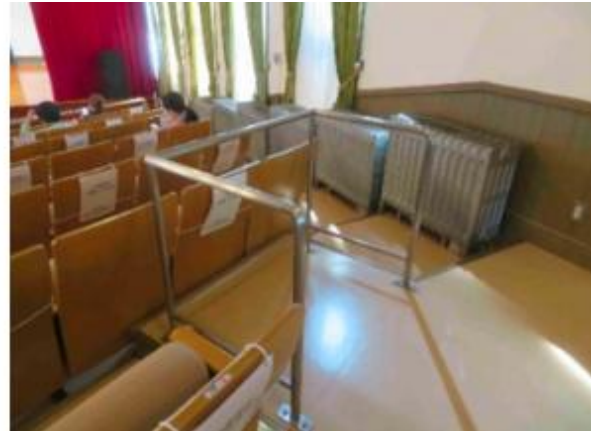
Figure 1a&b. Concert Hall, Tokyo Music School, and the wheelchair space in the hall

The first example, the Concert Hall of the Tokyo Music School (Fig. 1) was used for its original purpose until around 1980. Handed over to the Taito City in 1983, it was moved to its present position nearby. Major restoration was again done in 2018, but no means of access to the upper floor was provided where the audience seats are situated. There is one place for a person with a wheelchair, but no elevator is available. Since its significance is its pipe organ, whose performance is integral with the hall itself, and primary purpose of a concert hall is to have audience there, the lack of easily usable

access features would be a serious flaw. The author asked how one can reach there – the answer from the manager was that a special stair climbing facility will be arranged by a designated company upon request, who will operate the machine. The cost must be borne by the person with a wheelchair (or by the concert organizer).

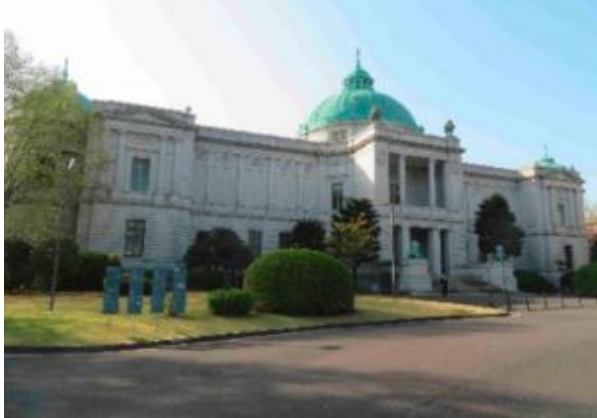
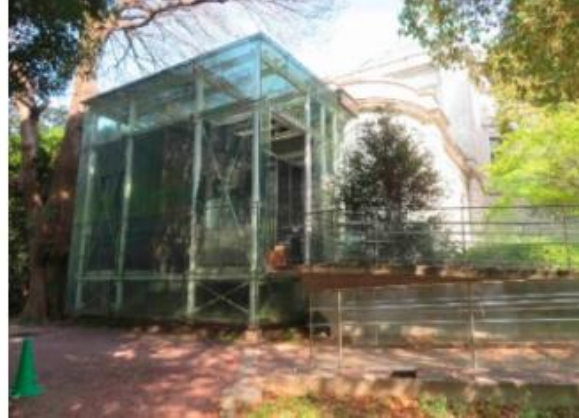
Figure 2a&b. Grand staircase at the front of Hyokeikan and glazed elevator at the back.

Three museum buildings at the Tokyo National Museum give good examples of ensuring accessibility in Museums. The first one, Hyokeikan (Fig. 2) was designed with a grand staircase at the front,

and it is not easy to make it accessible. It was decided to add a glazed elevator at the back with an access ramp, demonstrating that the building façade is intact but ensured a compromising full access. The Main Building (Fig. 3) is designed with a grand carriage porch, where one can drive a car through. There are additional steps to enter afterwards, and ramps were added on the left side, which everyone can choose to walk in lieu of steps. The Asian Gallery (Fig. 4) was designed to be stepless entry with elevator access to upper floors. With an atrium in the center, the exhibit spaces were made as skip floors, which unfortunately made the original elevators without full access to every floor – left side gave access only to odd number floors and the right side only to even number floors. Renovation in 2012 added a glazed elevator within the atrium – with access to all floors. It has doors on two sides, enabling access depending on the floor layout. By the way, elevators with two-side doors were not allowed until 2000 according to the regulation of the Building Standard Law.

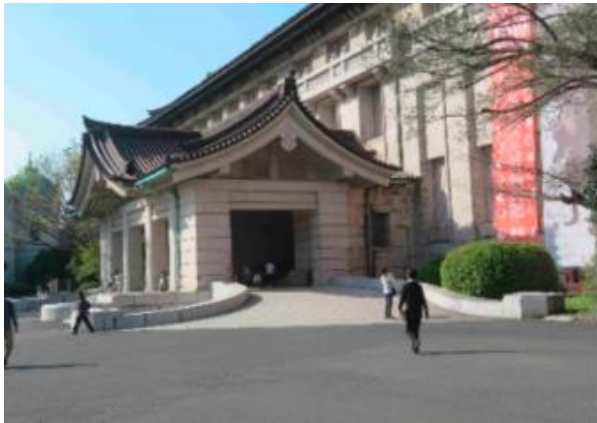
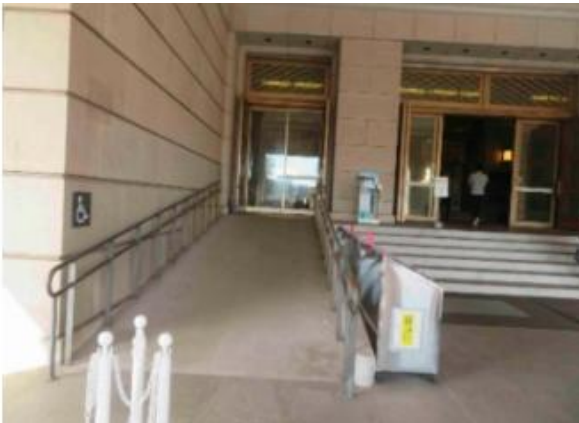
Figure 3a&b. Tokyo National Museum Main Building carriage porch and long ramp to the entrance.

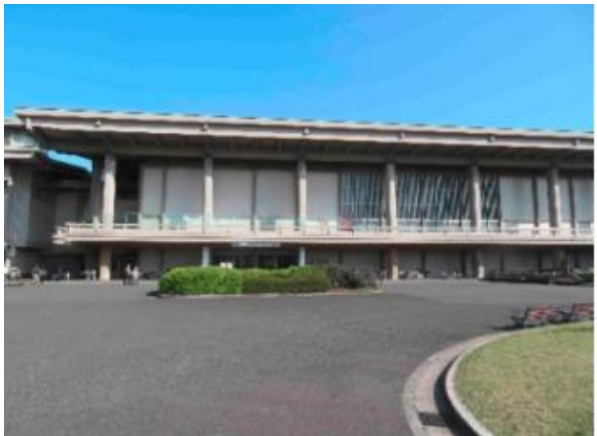
Figure 4a&b. Asian Gallery and the glazed elevator added in the atrium.

It is interesting to note the different approaches taken by the museum organizers regarding the renovation of Taniguchi designed buildings (neither is designated as an important cultural property). The Asian Gallery (Fig. 4) of the Tokyo National Museum basically kept the original floor plan layout, but the Museum of Modern Art Tokyo employed a more drastic approach. Originally, the building was designed with skip floors, but void inside was completely eliminated for structural integrity against earthquakes. It is now impossible to try to imagine the original arrangement. Only a tiny photograph showing the previous arrangement is displayed.

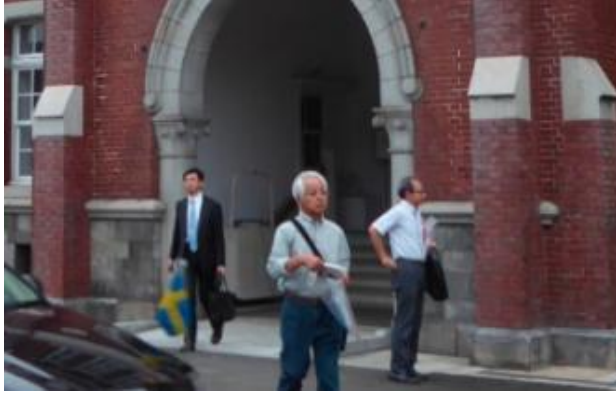
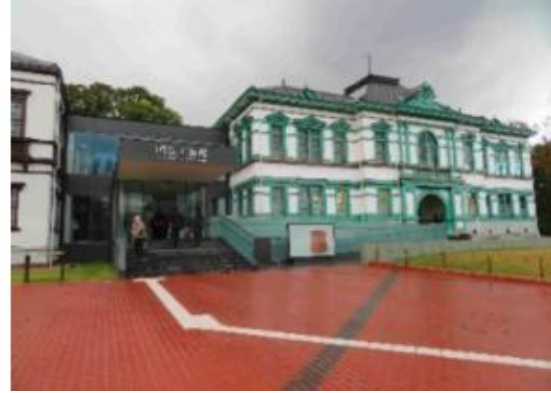
Figure 5a&b. Crafts Gallery, Museum of Modern Art Tokyo and the new National Crafts Museum.

Former Imperial Guards Building had been used as the Crafts Gallery of the Museum of Modern Art Tokyo between 1977 and 2020, and it had a stairlift at the entrance (Fig. 5a). The Gallery moved to Kanazawa and changed its name as the National Crafts Museum. Utilizing two old timber buildings of former Japanese Army, it is now fully accessible with long ramps (Fig. 5b).

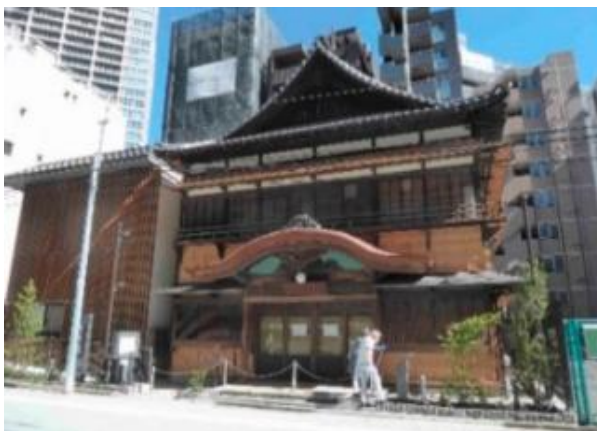
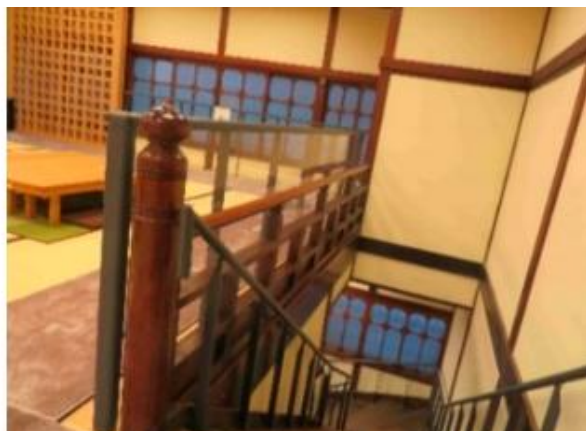
Figure 6a&b. Kenban with elevator annex on the left. Stair guard was added inside.

Two buildings owned by the Minato City, Tokyo, seem worth mentioning regarding accessibility provision. The Kenban (Fig. 6), originally built as the assignation office for geisha had been used as accommodation for port workers after the war. Valuing its historical significance as a surviving timber structure, the city obtained the building and renovated it to become a new Center for Traditional Culture. Using the adjoining land lot, a small building was built to house an elevator to be connected to the old timber structure. Designed to be a timber house next door, the annex just looks as if it has been in existence long since.

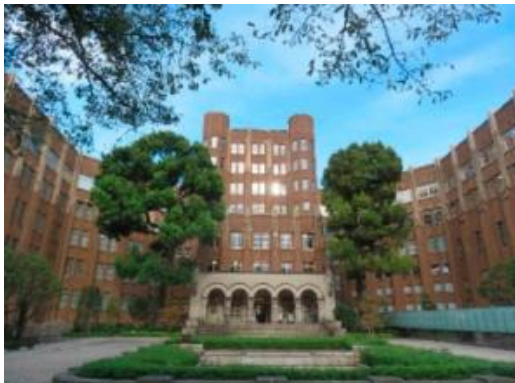
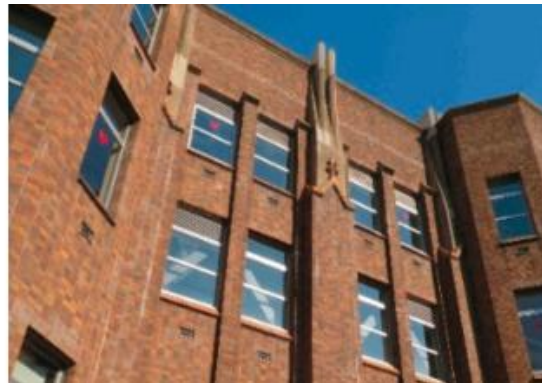
Figure 7a&b. Former Institute of Public Health. Long ramp on the right side, and structural reinforcement.

Another example, the former Institute of Public Health building became vacant after the Institute moved out of Tokyo. Since the building was in fairly good condition (built after the Great Kanto Earthquake with the donated funds from the Rockefeller Foundation), the Minato City decided to convert it for several functions including the Local History Museum. Structural reinforcement and accessibility provisions were extensively introduced (Figs. 7 and 8).

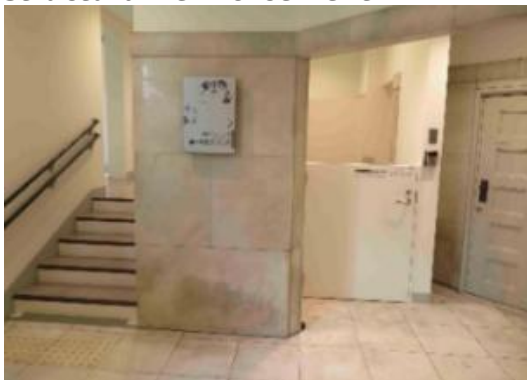
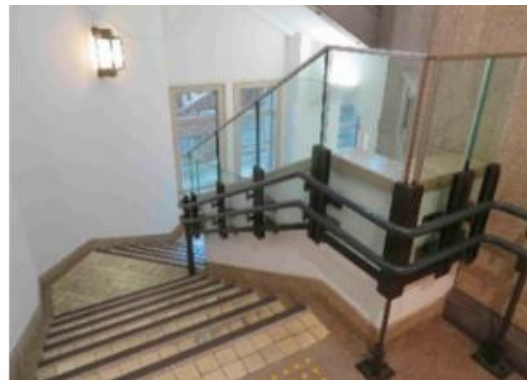
Figure 8a&b. Vertical lift at several places, and guardrail to prevent stair falls.
