# **Values-Based Conservation in Practice: Accessibility at Akershus Castle, Oslo**

## **Abstract**

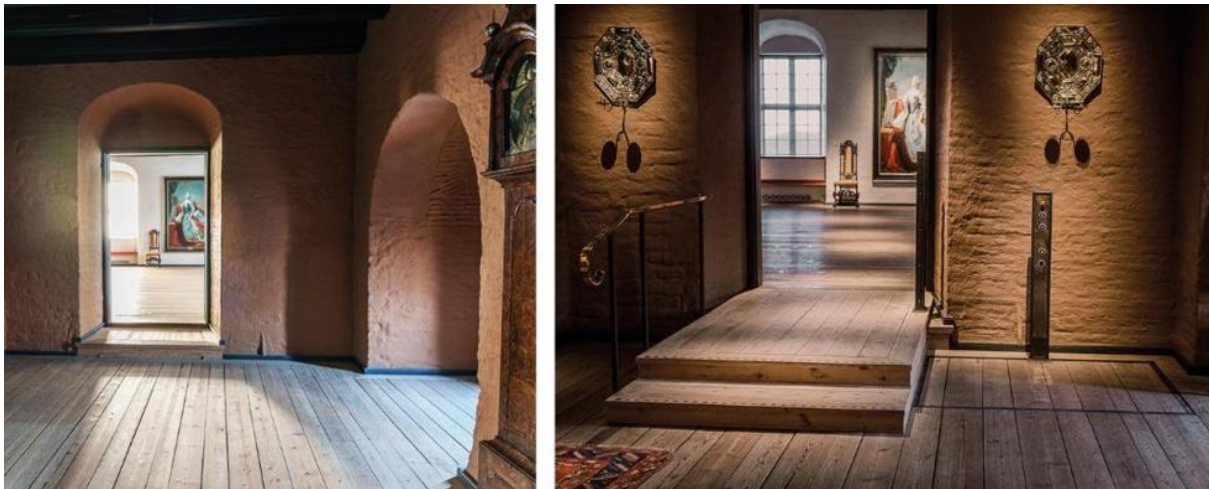
*Figure 3. L.h.s.: One of the halls before intervention. R.h.s.: A lifting platform is integrated in the floor. (Photo 1: Oslo Byggentreprenør AS; 2: A.M. Malkenes Mathiesen/The Norwegian Defense Estates Agency)*

installations. It was therefore crucial that all interventions were to be executed with the highest quality in design, materials, and craftsmanship (Figure 3 and 4).

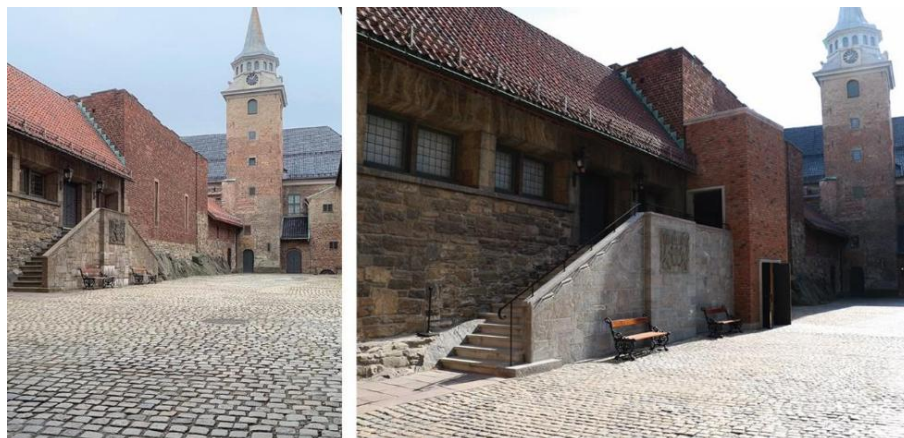
**Figure 5. L.h.s.: The courtyard before intervention. R.h.s.: An elevator tower has been established in connection with the new stair. (Photo 1: Arkitektskap AS; 2: M. Brenna)**

**Making then main entrance accessible is an example. The monumental and symmetrical limestone stair in the courtyard had to be dismantled entirely (Figure 5). The new stair was erected in an asymmetrical shape with a horizontal part connecting the elevator. The new stair had to be wider, and the landing higher than the original. All the old limestones in the front and railing where reused and adapted to fit the new shape. Due to the new hight an additional iron railing had to be mounted.**

**One of the most important alterations, however, was erecting the new tower, containing the elevator, in the courtyard. This represents a major change from a heritage perspective and the courtyard's appearance (Figure 5). Thus, it was imperative to find the right balance making the elevator functional, easily visible, and as prominent as the main entrance – and making the addition blend into the historical environment. The result combines use of traditional materials such as limestone, bricks, and iron, but with a contemporary interpretation. The new tower is placed on the footprint of the first medieval tower at Akershus, but it has a clear contemporary character, and represents an addition to the castles long history of alterations.**

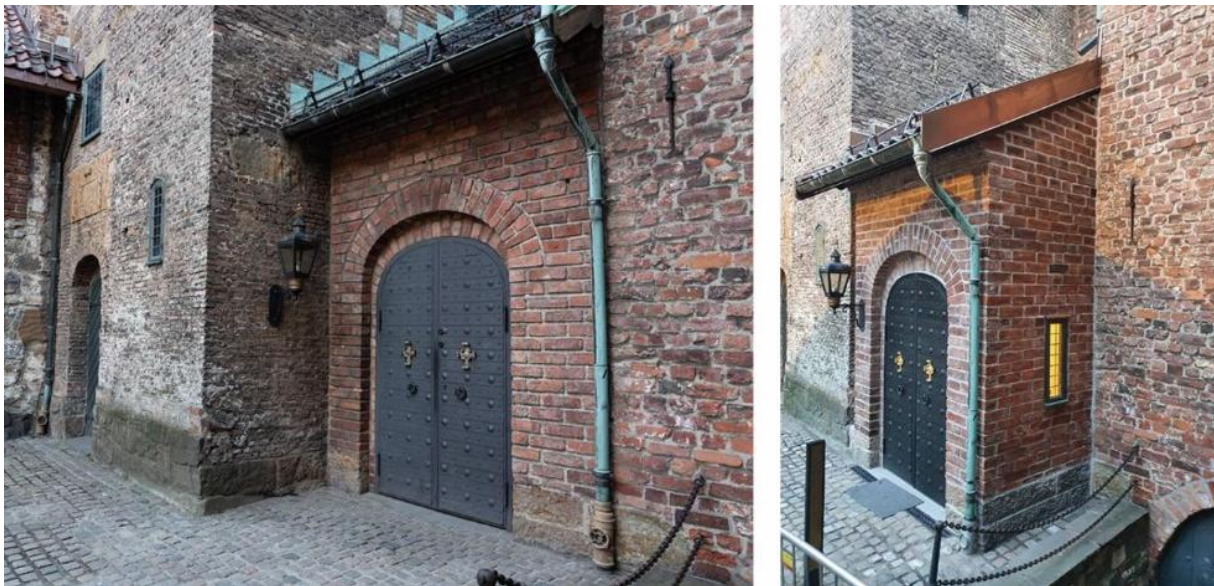
**Figure 6. L.h.s.: The church's entrance hall before intervention. R.h.s.: The church's entrance hall after intervention. (Photo: Oslo Byggherred AS)**

The church entrance is an example where the limitations in the existing castle and heritage values limited the possibility for accessibility interventions. In spite of expanding the entrance hall, there was not enough room for an elevator and a stair (Figure 6). The result was fitting a lifting platform integrated in the stair (Figure 7). To obtain the overall architectural quality, the platform is covered in the same marble as the stair, making it almost invisible, when not in use. When it is in use the stair is not blocked for others, so the entrance complies fully with the aim to accomplish equality and dignity.

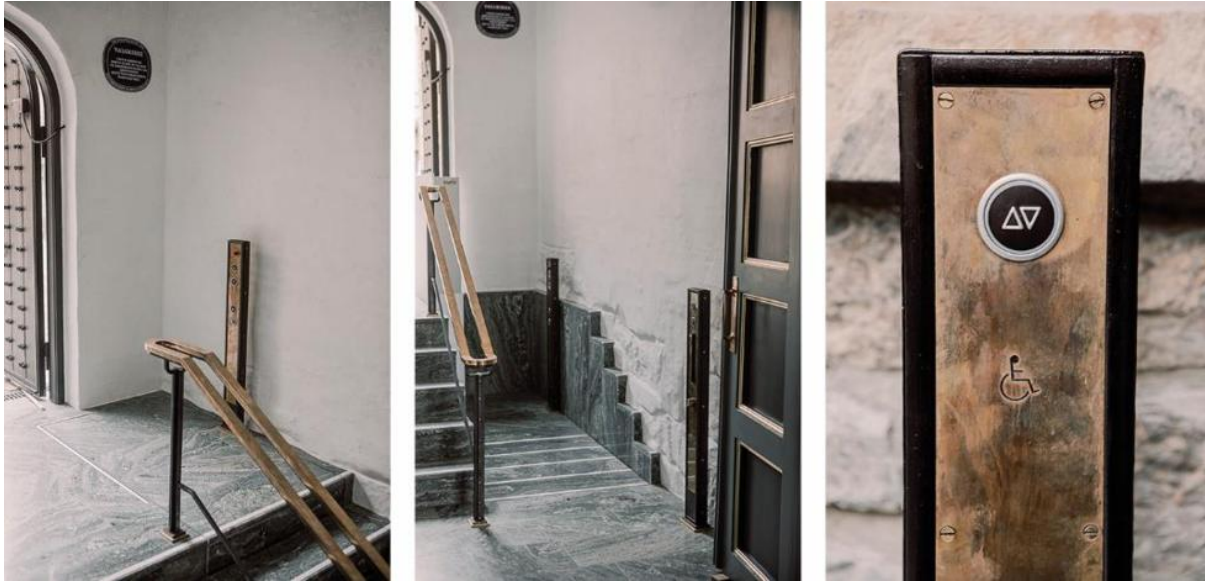
**Figure 7. A lifting platform is integrated in the stair in the church's entrance hall. (Photo: Anne-Margrethe Malkenes Mathiesen/The Norwegian Defense Estates Agency)**
